HOBSON'S CHOICE HOME INSPECTION

INSPECTION REPORT

1234 Se Anywhere Ln
Portland OR 97206

Property Address:	1234 SE Anywhere Ln Portland OR 97206
Date of Inspection:	6/13/2013
Persons in Attendance:	John Smith/Client Jane Doe/Realtor
Weather:	Cloudy / Showers
Temp Range:	60-65
Recent Rain:	Today
Building Type:	SFR / Ranch
Approximate Age of Dwelling:	1973
Orientation of Dwelling:	Northern Exposure

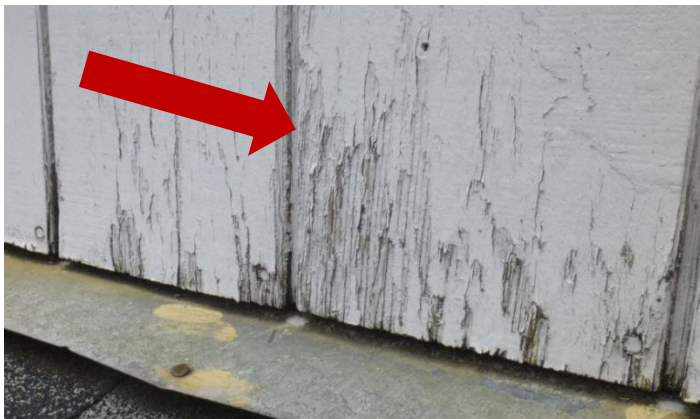
Comments: Painted wood siding in better than average condition considering age of home. First photo shows minor damage above roof on eastern exposure. Second photo shows soffit sag on southeast corner of home. Recommend monitoring of siding damage. Recommend repair of soffit since it is causing slight dip in roof and pooling of water.

- Exterior:** Recommend repair of soffit on SE corner and dip in roof directly above same location. Monitor weather damage to siding above roof on eastern exposure.

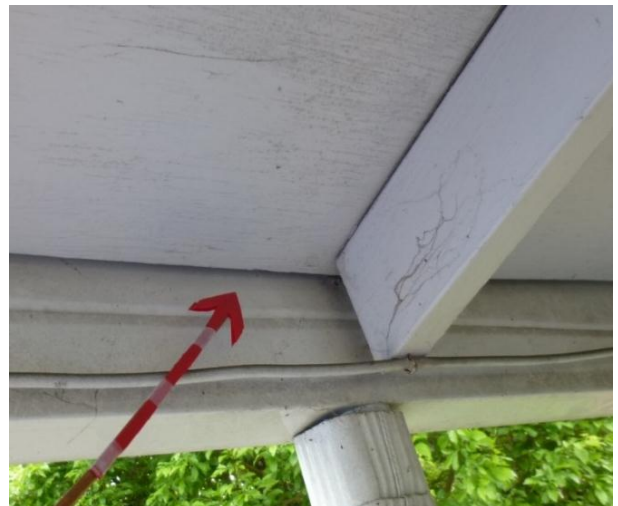
Comments: See picture of sagging soffit under siding section above. Recommend monitoring of siding damage. Recommend repair of soffit since it is causing slight dip in roof and pooling of water.

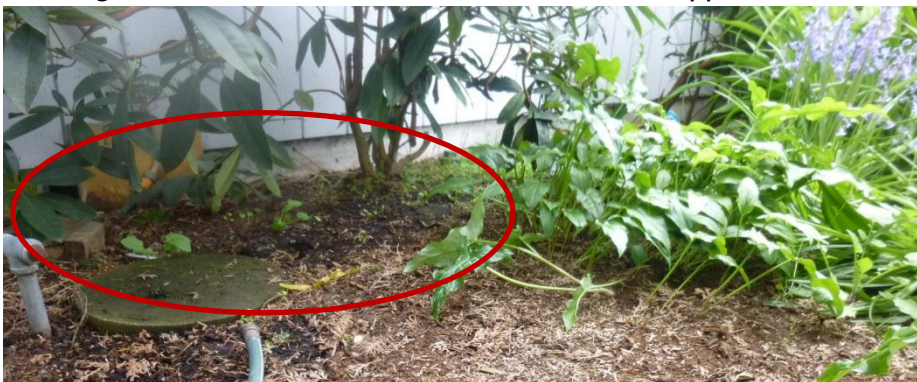
Vegetation:	Trimmed properly / not touching siding
Grading:	Ground near front door drains water toward foundation
Drainage:	Good except near front door
Driveway Type:	Concrete / normal cracking / caulked / no offsets
Walkways:	Brick pavers in backyard / no offsets
Retaining Wall:	N/A

Comments: Recommend changing landscaping slightly near front door. Ground is draining water toward foundation; it should be the opposite.

- Drainage:** Recommend changing soil level near front door to drain. Direct water away from foundation, not toward it. Recommend re-attaching the rain leader on gutter east side of home.

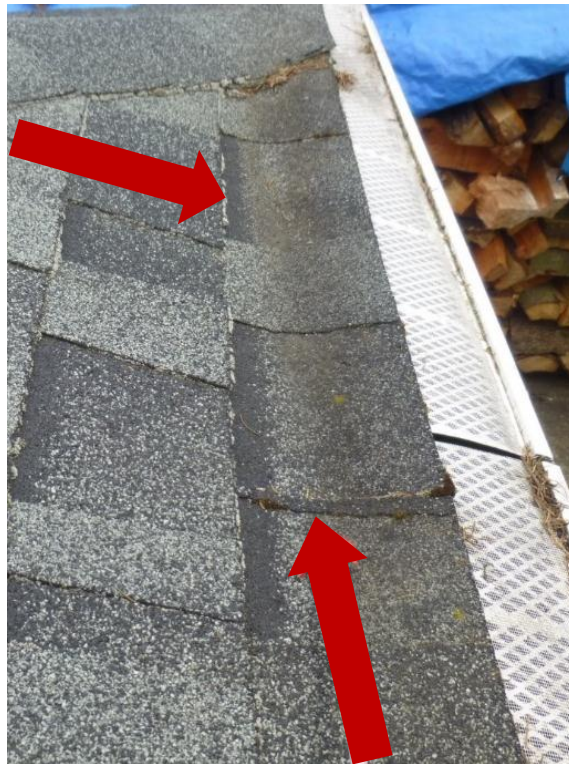
Comments: Slight sagging on SE corner of roof allowing water to pool. Recommend repair before water damage to underlying structure takes place. This may be connected to sagging soffit mentioned above.

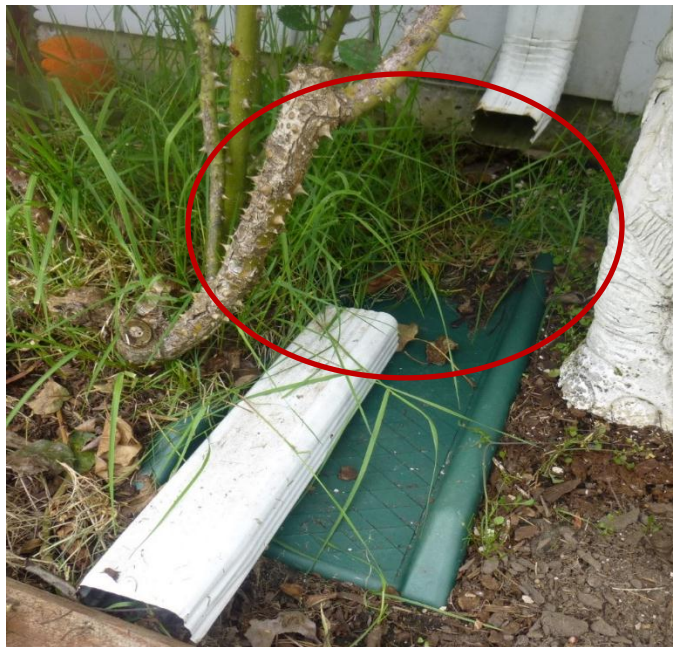
Comments: Bottom of downspout separated on NE corner. Recommend to re-connect.

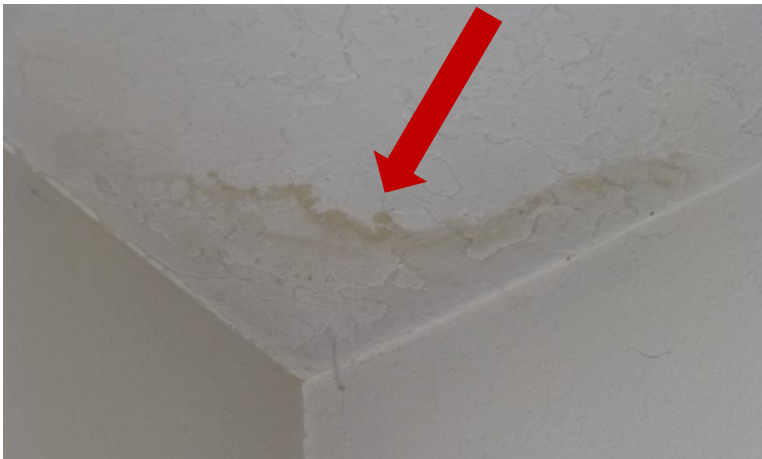
Comments: One small water stain on ceiling in family room. Owner states it has been there for years and has not enlarged. Unable to locate any current roof leakage. Recommend monitoring.

- Interior:** Recommend monitoring of water stain on ceiling in family room.
- Appliances:** Recommend replacement of water heater.

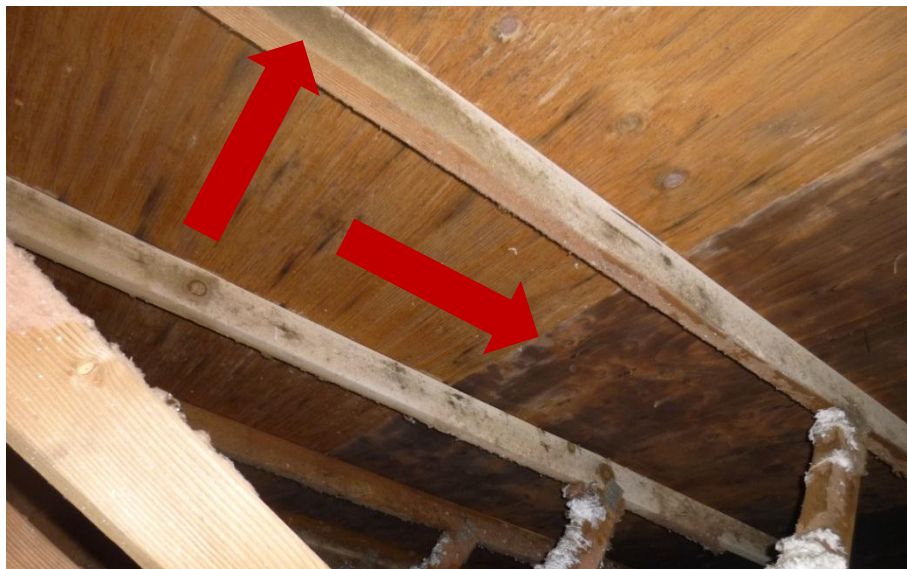
Comments: Some evidence of mold/mildew on rafters. Slight discoloration found on bottom side of roof sheathing. Found no signs of ongoing water penetration from roof. Mildew could be a result of condensation alone. Recommend removal of storage items to improve ventilation and monitor mildew. If condition continues or worsens, recommend professional treatment.

Comments: All vents are screened. As mentioned above in roof and attic structures there is evidence of minor molding on rafters and underside of roof sheathing in attic. See picture in roof structures.

- Attic Ventilation:** Recommend removal of storage items, cleanup affected areas and monitor for any reoccurrences.
- Small Bath:** Recommend removal of mold and increase ventilation.

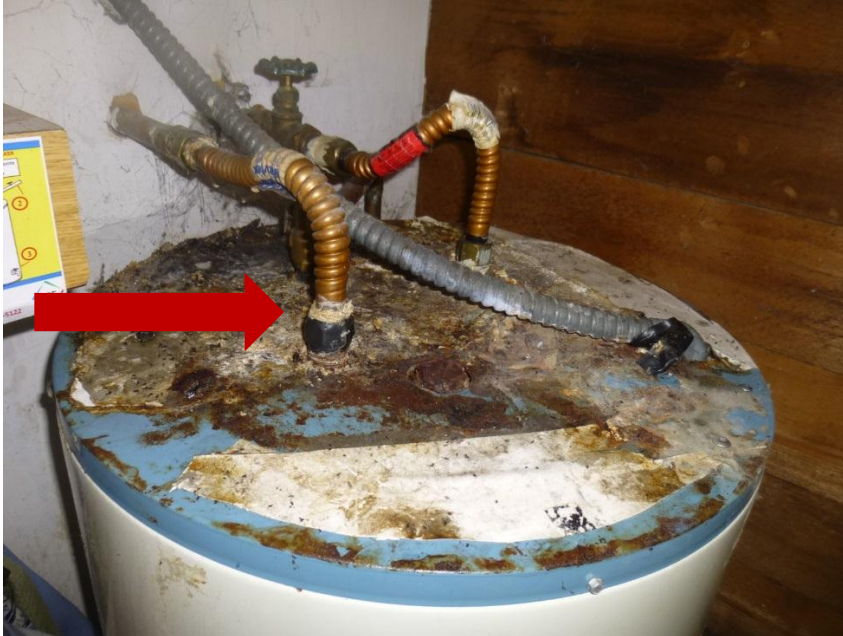
Comments: Water heater is heavily rusted on top and bottom. Appears there has been long term leakage at water exit fitting. Damage and date of manufacture dictate replacement of this appliance.

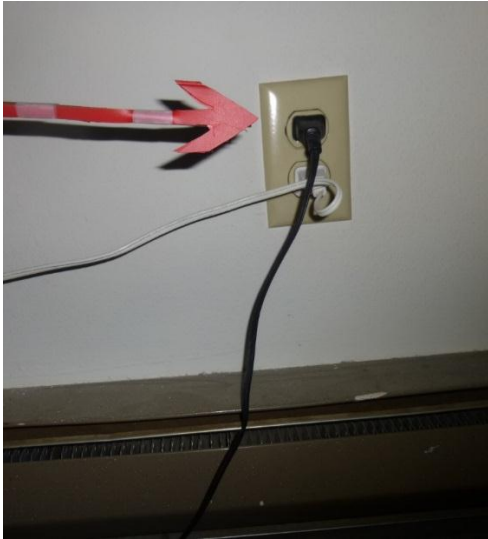
Comments: No discrepancies noted. Safety note: During time of construction it was deemed ok to place fixtures over baseboard heating. New construction does not allow this practice. Electrical cords may become overheated if in contact with heater. Recommend extreme caution when in use.

- Electrical:** Recommend extreme caution utilizing outlets directly above baseboard heaters. Lack of smoke detectors; recommend getting them added to each bedroom. Recommend replacing current outlets with GFCI outlets in both bathrooms and kitchen.

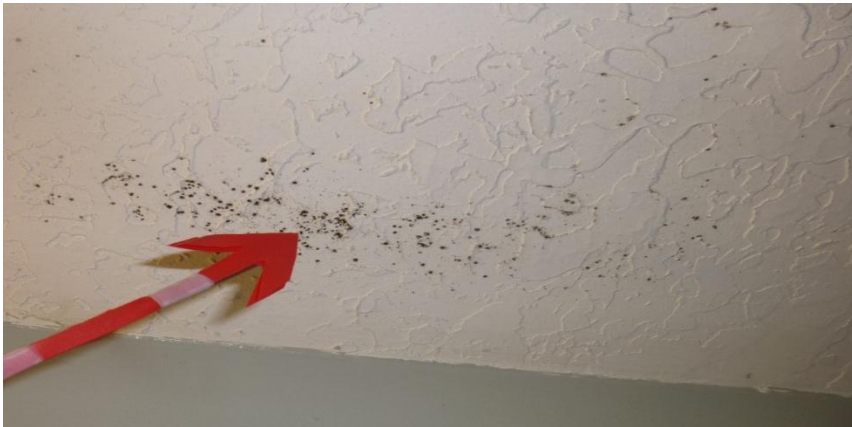
Comments: Front bath has a fan and is functioning properly. The back bath has minor mold problem as a result of poor ventilation. Recommend removal of mold and develop method to increase airflow especially during shower operation.
